# **Critical Studies in support of the Ageing Management of NPP Concrete Infrastructure – CONAGE**

**KYT2022-SAFIR2022 Interim Seminar**

19.03.2021

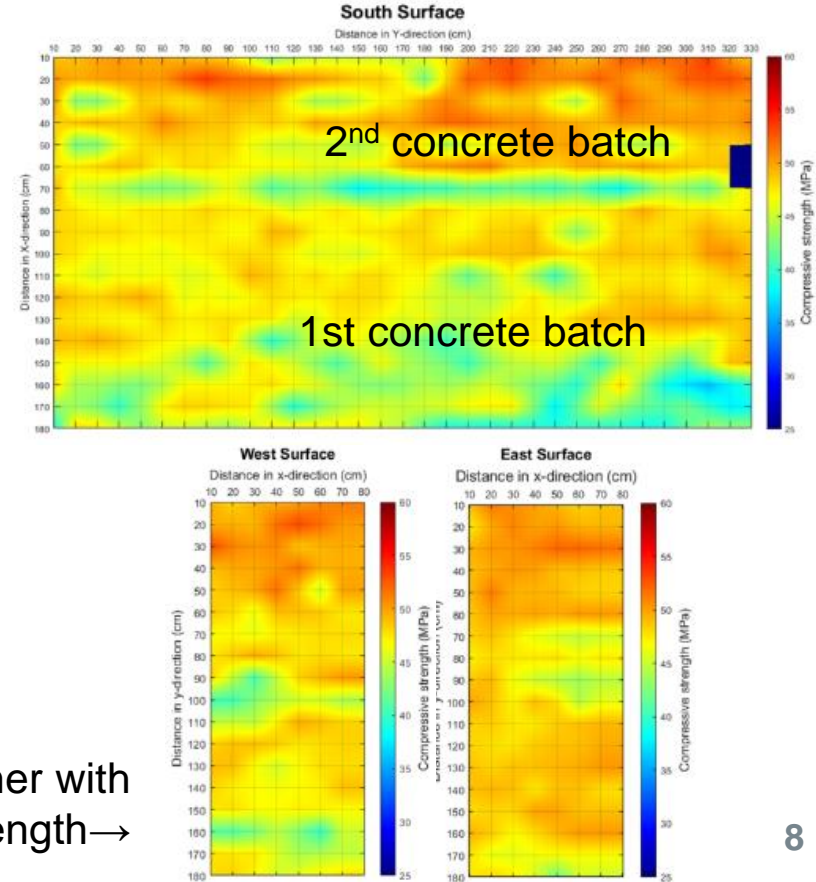
- Combined NDT techniques:
  - Rebound hammer (R-value and Q-value)
  - Ultrasonic pulse velocity (UPV)
  - Coring samples for calibration of compressive strength with SonReb method
- Rebound hammer
  - 9 points in 100cm<sup>2</sup>, calculated median
- UPV
  - Best fit straight line of 4 measurements

Combined R-value rebound hammer with UPV – Estimated compressive strength→

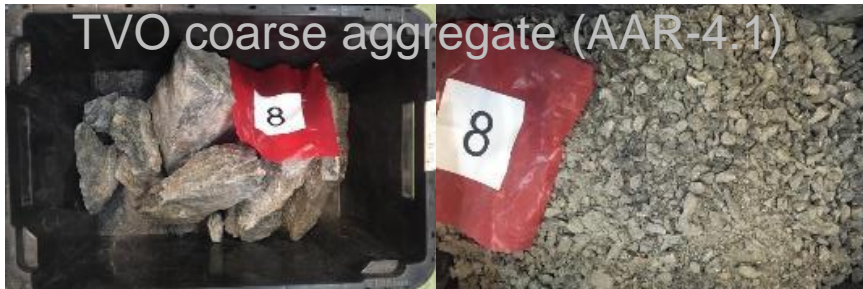
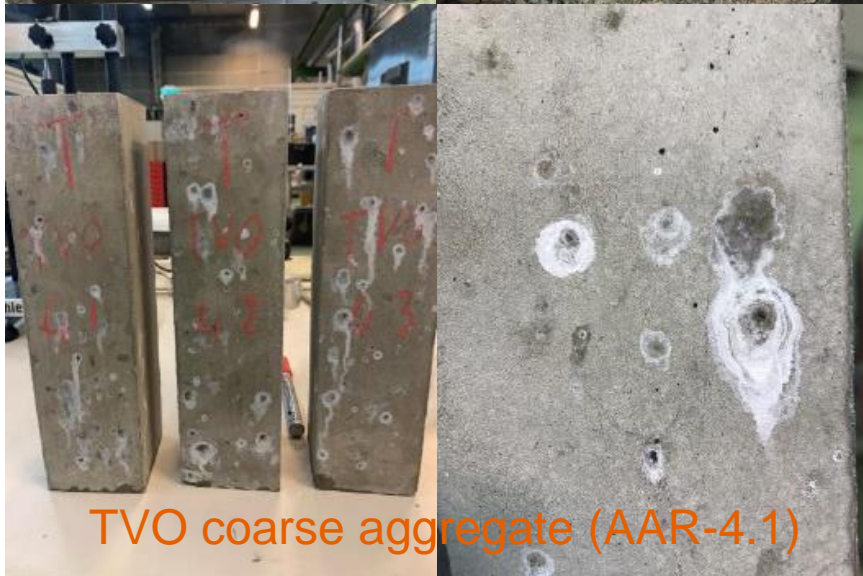
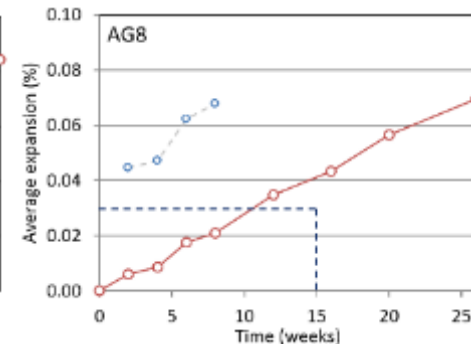
TVO coarse aggregate (AAR-4.1)

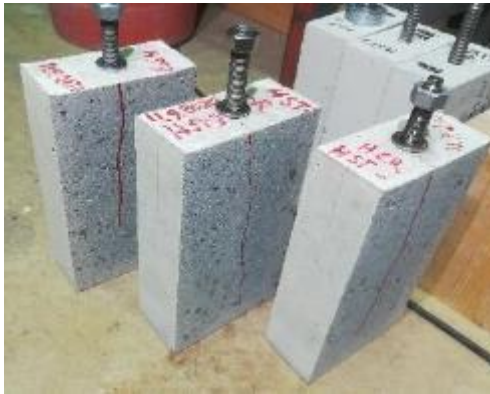
- Study the corrosion characteristics of three types of anchors: undercut, expansion, and bonded anchors (ordinary, galvanised, stainless steel anchors)
- Sample subject to accelerated deterioration using carbonation (4-5 vol% CO<sub>2</sub>, 60% RH, T = 22 °C), and cyclic wetting/drying (1day/6days) with 20% NaCl

Pre-testing  
wedge anchors

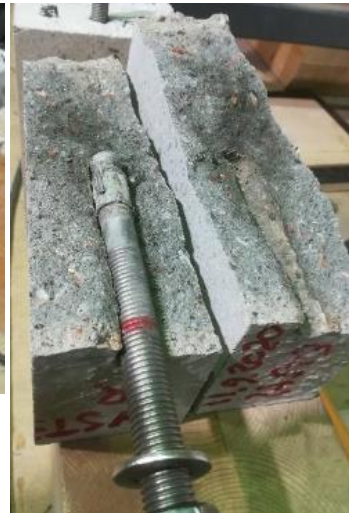
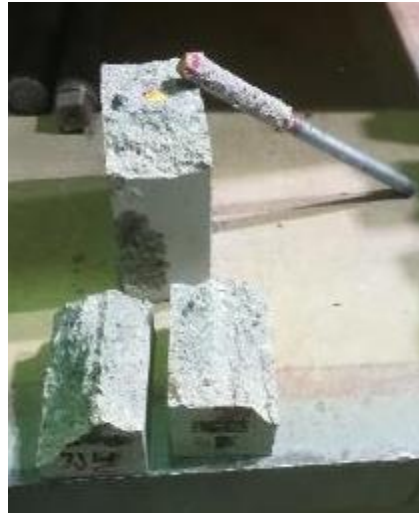
Pre-testing  
epoxy anchors
